Recreational Boat Collision Accident Research

Volume 1

Miles A. Beam III, P.E.
Senior Project Engineer
Marine Department

Underwriters Laboratories Inc.

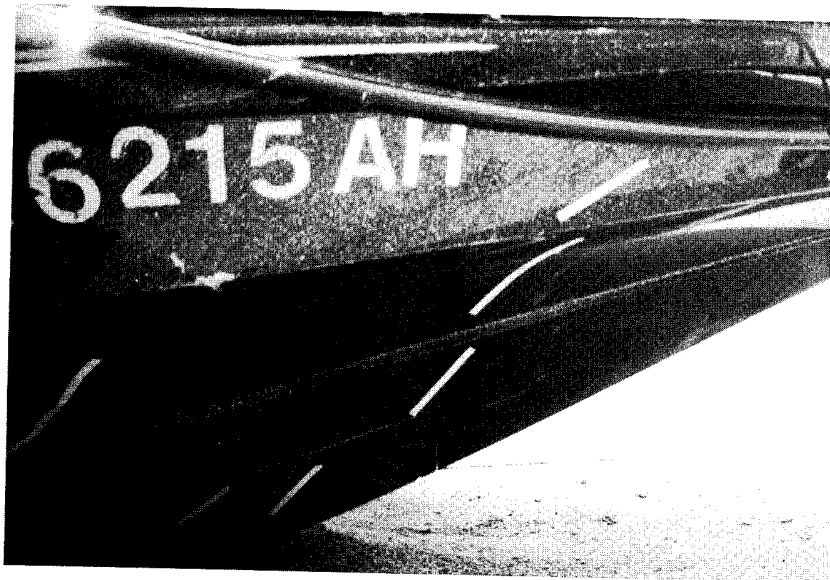
The most important data obtained from the bullet boat was the striations which were left on the bottom of the forward half of the hull. Most of the striations were located on the starboard side of the bullet boat hull. A few small ones were located on the port side near the bow. Figure 13-1 and 13-2 show the striations. Since many of the striations were light, and would not show up on film, masking tape was placed next to the longer and deeper striations in order to ensure that the direction of these scratches was documented. The distance of the striations from the front of the boat was noted so that they could be properly located on a damage diagram. Figure 13-2 shows where two chunks of fiberglass were removed from the spray rails. This type of damage is typically caused when the bullet boat bottom catches a deck cleat, hand rail, or other hard metal object. Often the object on the target boat which caused this damage can be located and identified. It was especially significant that no striations could be found on the rear half of the bullet boat hull bottom. Figure 13-3 shows the striations as documented on the bullet boat.

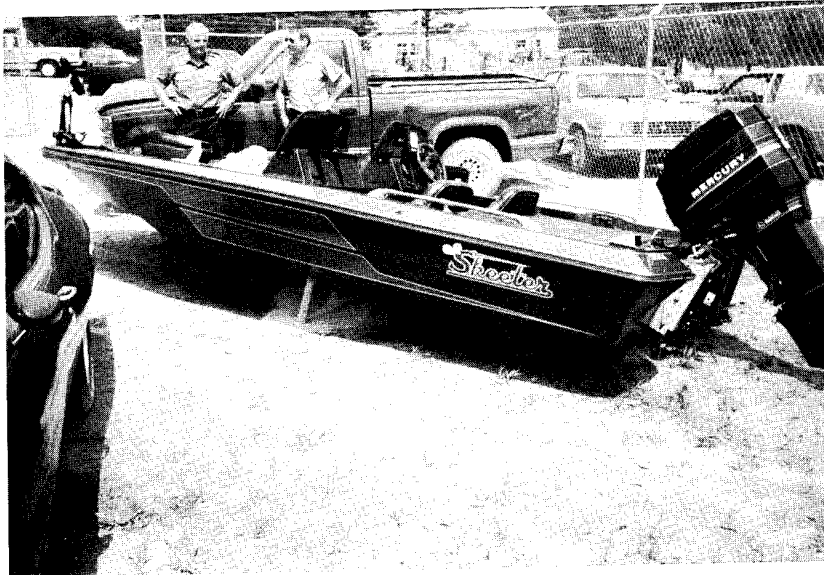
Figure 13-6

Damage to the bullet boat, shown in Figure 13-6, was relatively light. The hull appeared to have nearly severed from the deck cap, especially at the forward part of the boat. The hull had even cracked at the gunwale about half way back on the starboard side. This damage could have been caused by contact with the target boat during the collision. It could also have been caused another way. If the boat rolled severely to starboard while airborne, it could have landed on its side when it re-entered the water. This type of rolled attitude re-entry has been known to

cause separation of the hull and deck joints during earlier experimental collisions. Stress cracks all along the hull side may also be visible from extreme flexing of the hull side which also may occur during re-entry into the water. There was not sufficient information to determine if the boat rolled as a result of the collision.

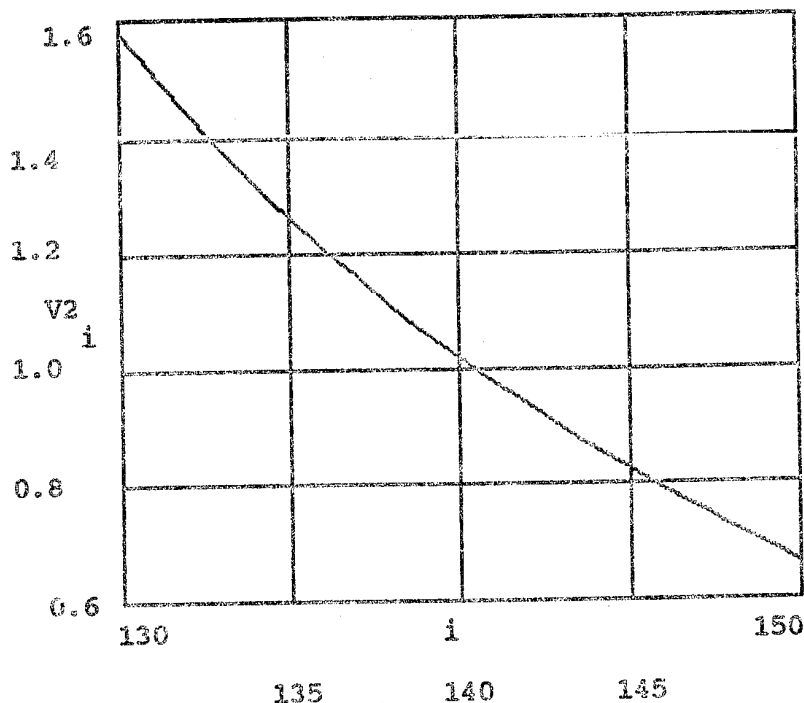
Figure 13-8

What do the charts tell us? Look at Figure 13-8. If the value of θ_3 is 139 degrees, then $VR = V2/V1 = 1.066$. This means that the magnitude of V2 was 1.066 times that of V1. Or stated another way, if the speed of boat 1 was 50 mph, then the speed of boat 2 was 50×1.066 or 53.3 mph. Remember that while the actual calculations may be quite precise, the numbers that go into them are only approximations at best. This technique should not be presumed to produce velocity ratios with great precision. These methods produce only approximations.

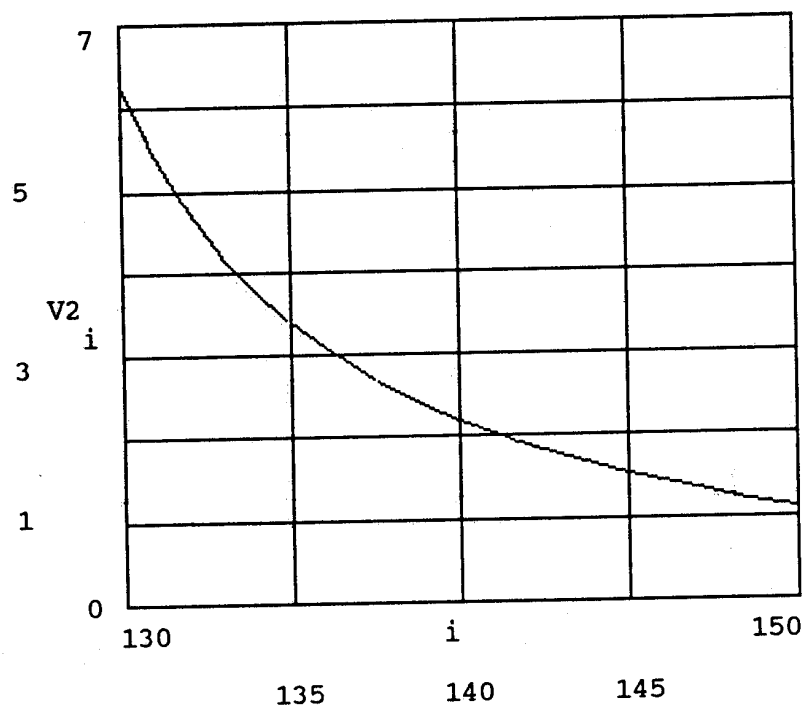
Figure 13-10

Witness statements initially estimated the speed of the bullet boat at approximately 25 mph and the target boat at 60 mph. This is a velocity ratio of V_2/V_1 of 2.4. From the VR charts, using the measured striation angle ($\theta_3 = 139$ degrees), we need a value for θ_2 of 123 degrees (see Figure 13-10) to achieve a velocity ratio close to that. We see that these speeds are possible. If these speed estimates are accurate, it is also likely that the target boat would have been in a hard turn to starboard, which would have helped to create the consistency needed between the damage to the top of the outboard motor and the striations on the bottom of the bullet boat. This analysis also assumes an initial impact point on the target boat at the leading edge of the damage, approximately seven feet aft from the bow.

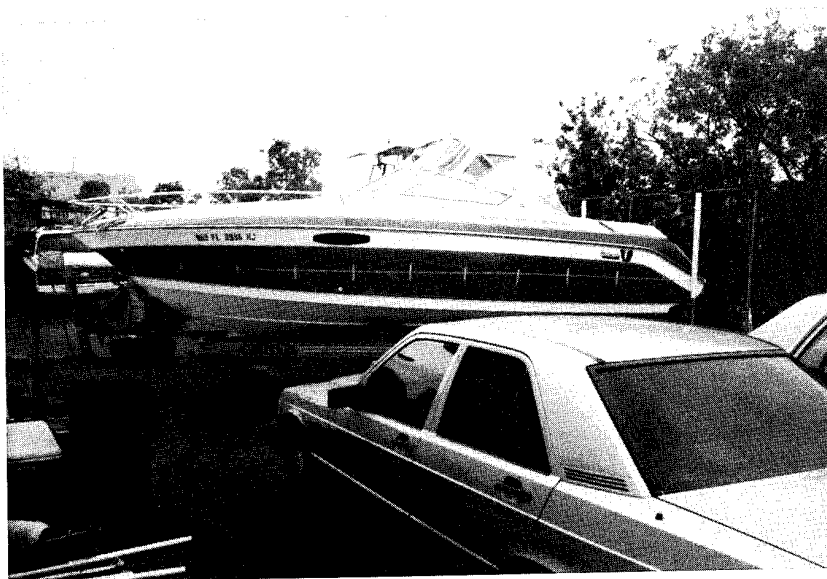
Figure 13-12

The accident happened near shore, and both boats rested in shallow water among a group of mangroves. The mangroves caused additional damage to the boats, especially to the cruiser. Figures 13-12 and 13-13 show overall views of the cruiser and ski boat respectively.

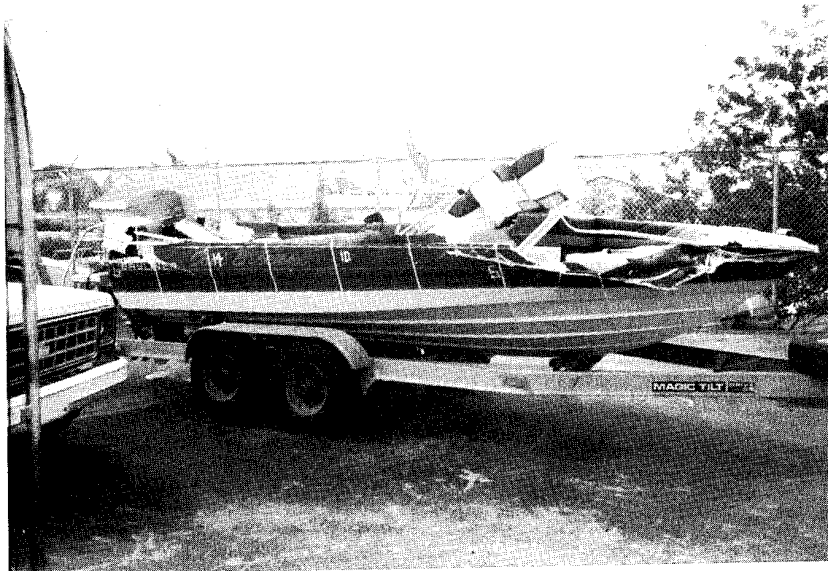
The damaged area on the starboard bow of the target boat shown in Figure 13-13 is believed to be the initial impact area. The notch in the forward most part of the "V" shaped section is likely where the bow hook of the bullet boat passed through. Dimensions

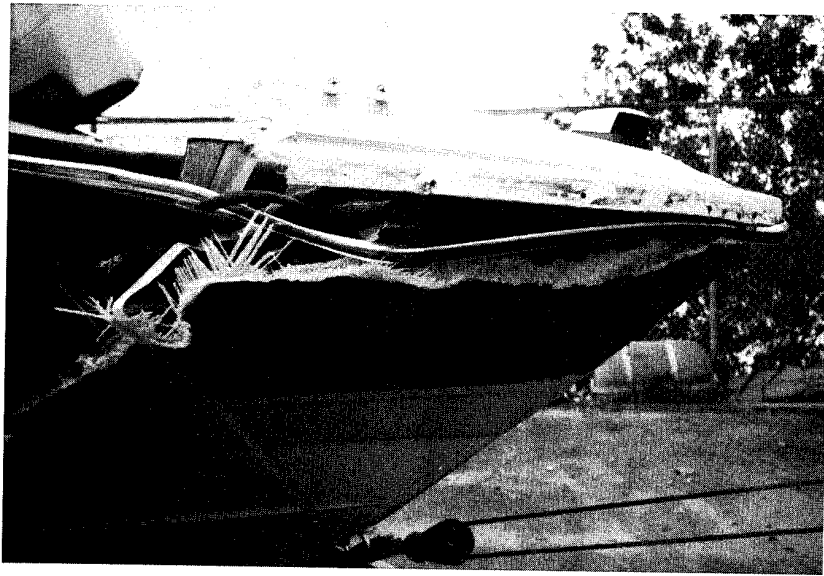
Figure 13-14

The starboard bow was badly damaged. A large vee shaped cut was carved into the hull. The forward edge of the vee shaped cut-out was a notch shaped cut as shown in Figure 13-14. This notch was believed to have been from penetration of the bow hook on the bullet boat.

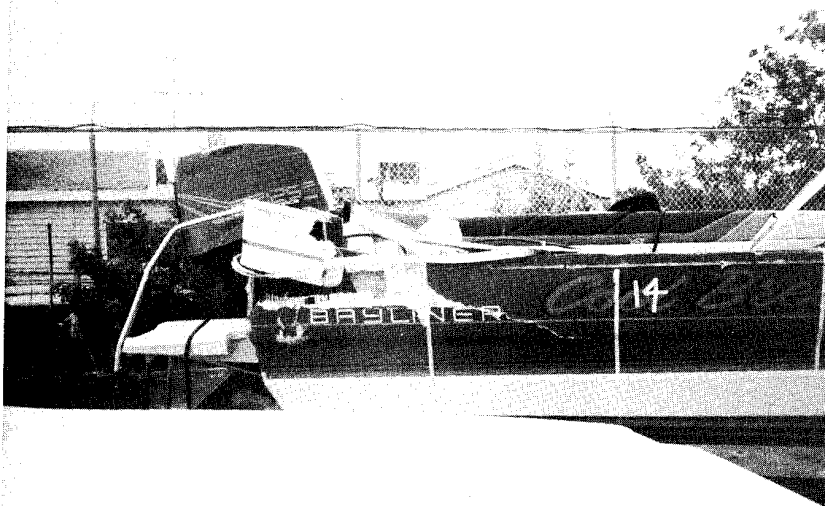
Damage to the starboard rear quarter near the stern as shown in Figure 13-15 may have been the area where the outdrive impacted; however, investigators informed UL that rescuers on the scene had to literally cut part of the ski boat out of the way in order to get to occupants trapped in the wreckage. Without knowing any more details of what was cut away, it was difficult to distinguish between impact damage and damage caused by the rescuers. The most forward edge of the area of the corner appears as though it may have been impact damage. The horizontal cuts adjacent to it are much cleaner as though a saw had been used.

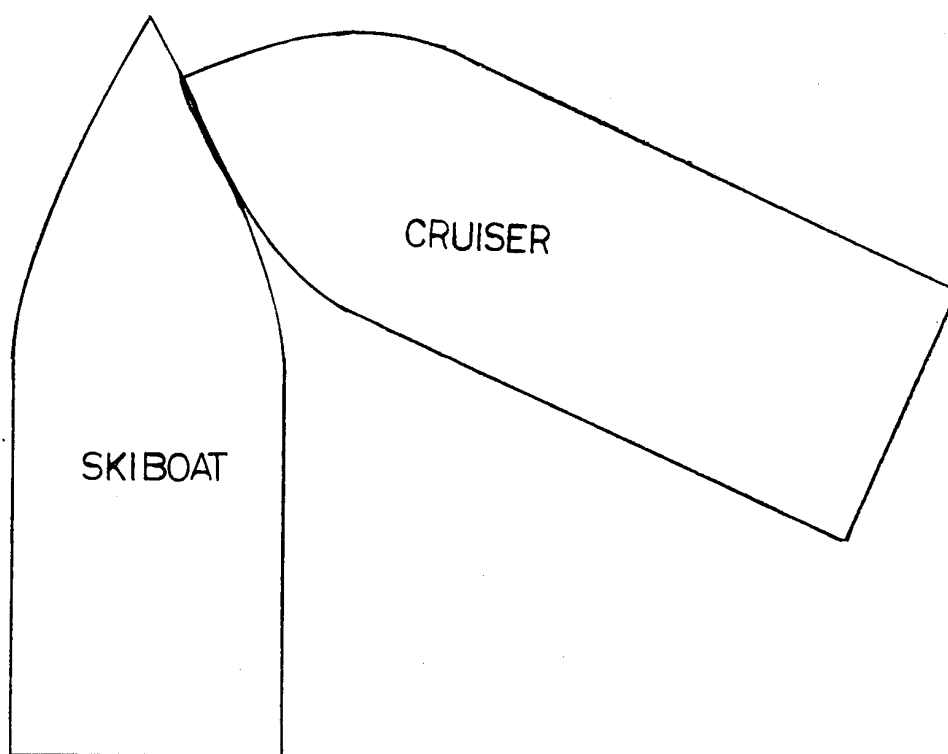
Figure 13-17

This Diagram Shows How the Striation Marks on the Bow of the Cruiser Might Have Been Made. Note That a Large Area of the Two Boats is in Contact.

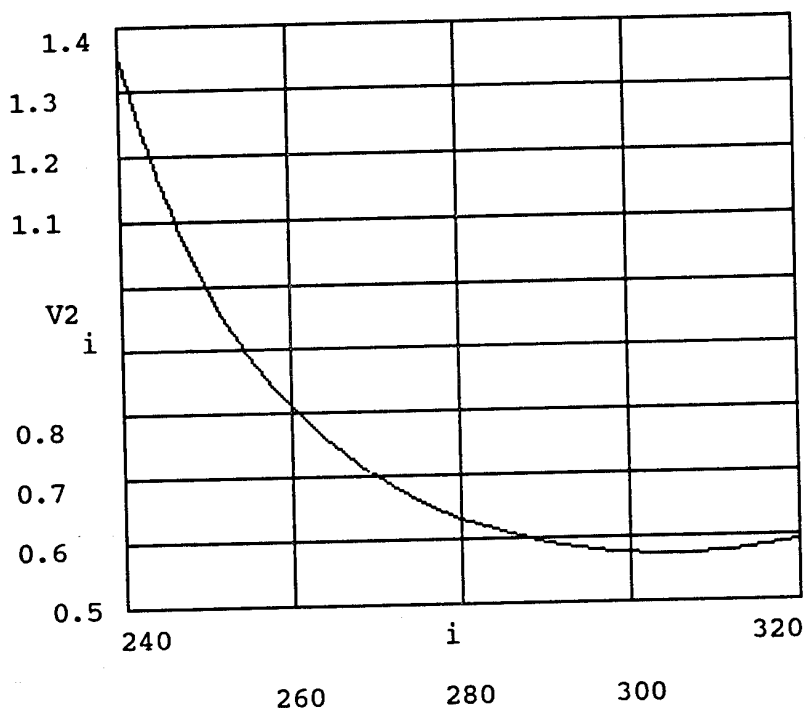
Figure 13-21

From Figure 13-21, $VR = 0.911$

From Figure 13-21, $VR = 0.576$

In this graph, i represents the range of possible impact angles (not striation angles).

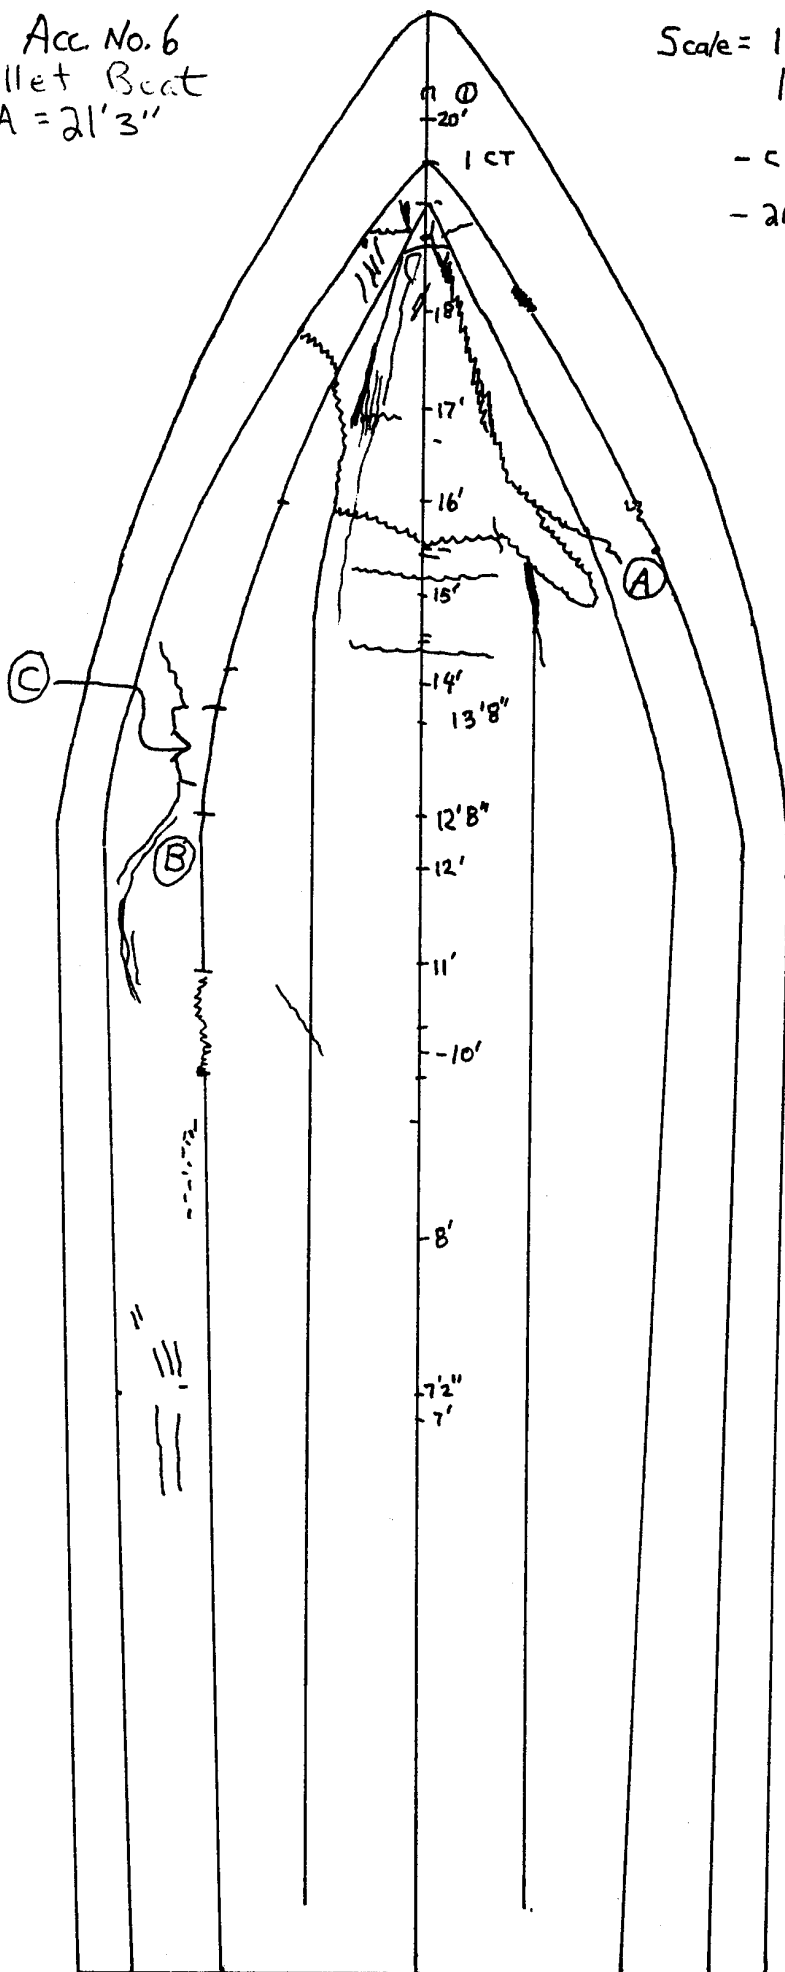
While it is difficult to explain in words alone, the "S" striations located at point B in Figure 13-43 made sense when examined in light of the pivoting hypothesis. If one takes the damage diagrams and maneuvers the boats through the sequence, it becomes more apparent how these marks might have been created as the boat pivots.

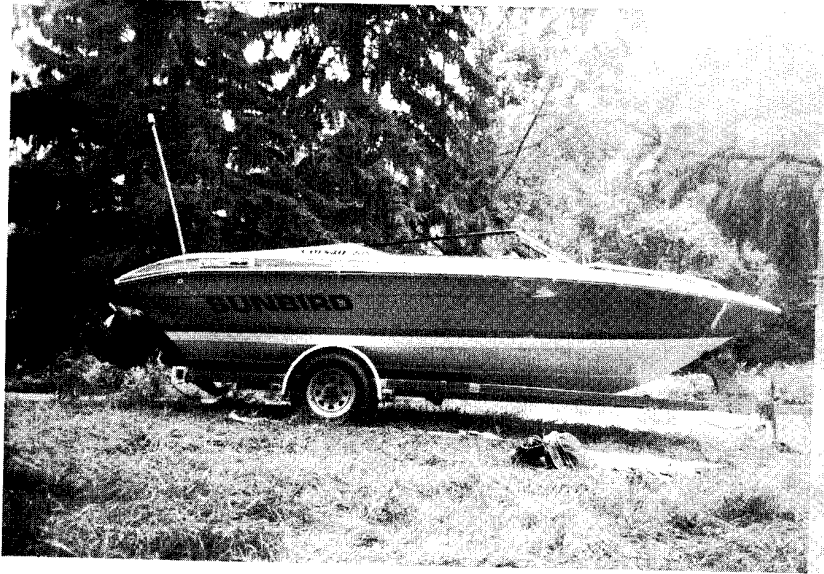
Figure 13-47

A 20 foot I/O open motor boat struck a stationary 21 foot long cuddy cabin cruiser. The boats are shown in Figures 13-47 and 13-48 respectively. The impacting boat struck the cruiser from nearly dead astern and rode completely over the cruiser. Fortunately, no fatalities occurred as a result of this accident.

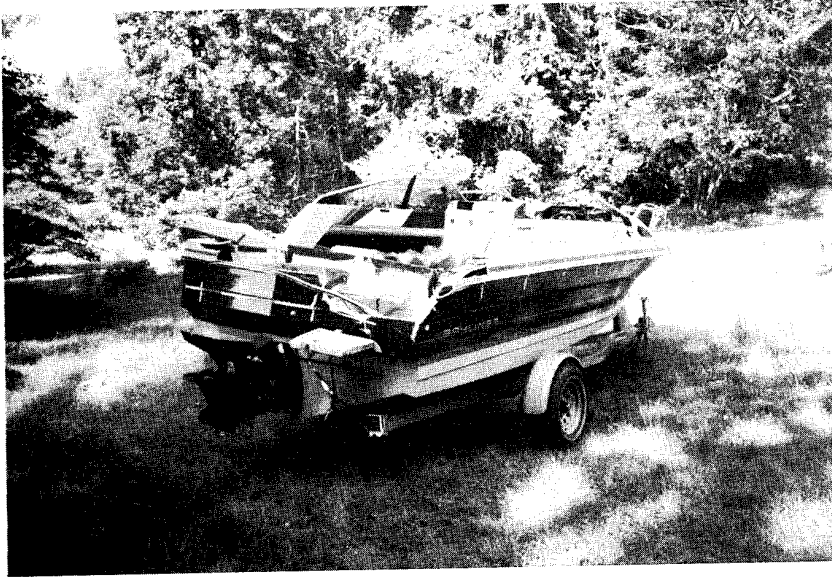
Figure 13-49

The struck boat was struck on the starboard side of the transom. This area is shown in Figure 13-49. The windshield frame on the starboard side of the boat had been severely damaged. The instrument console suffered from an impact either by the bow of the

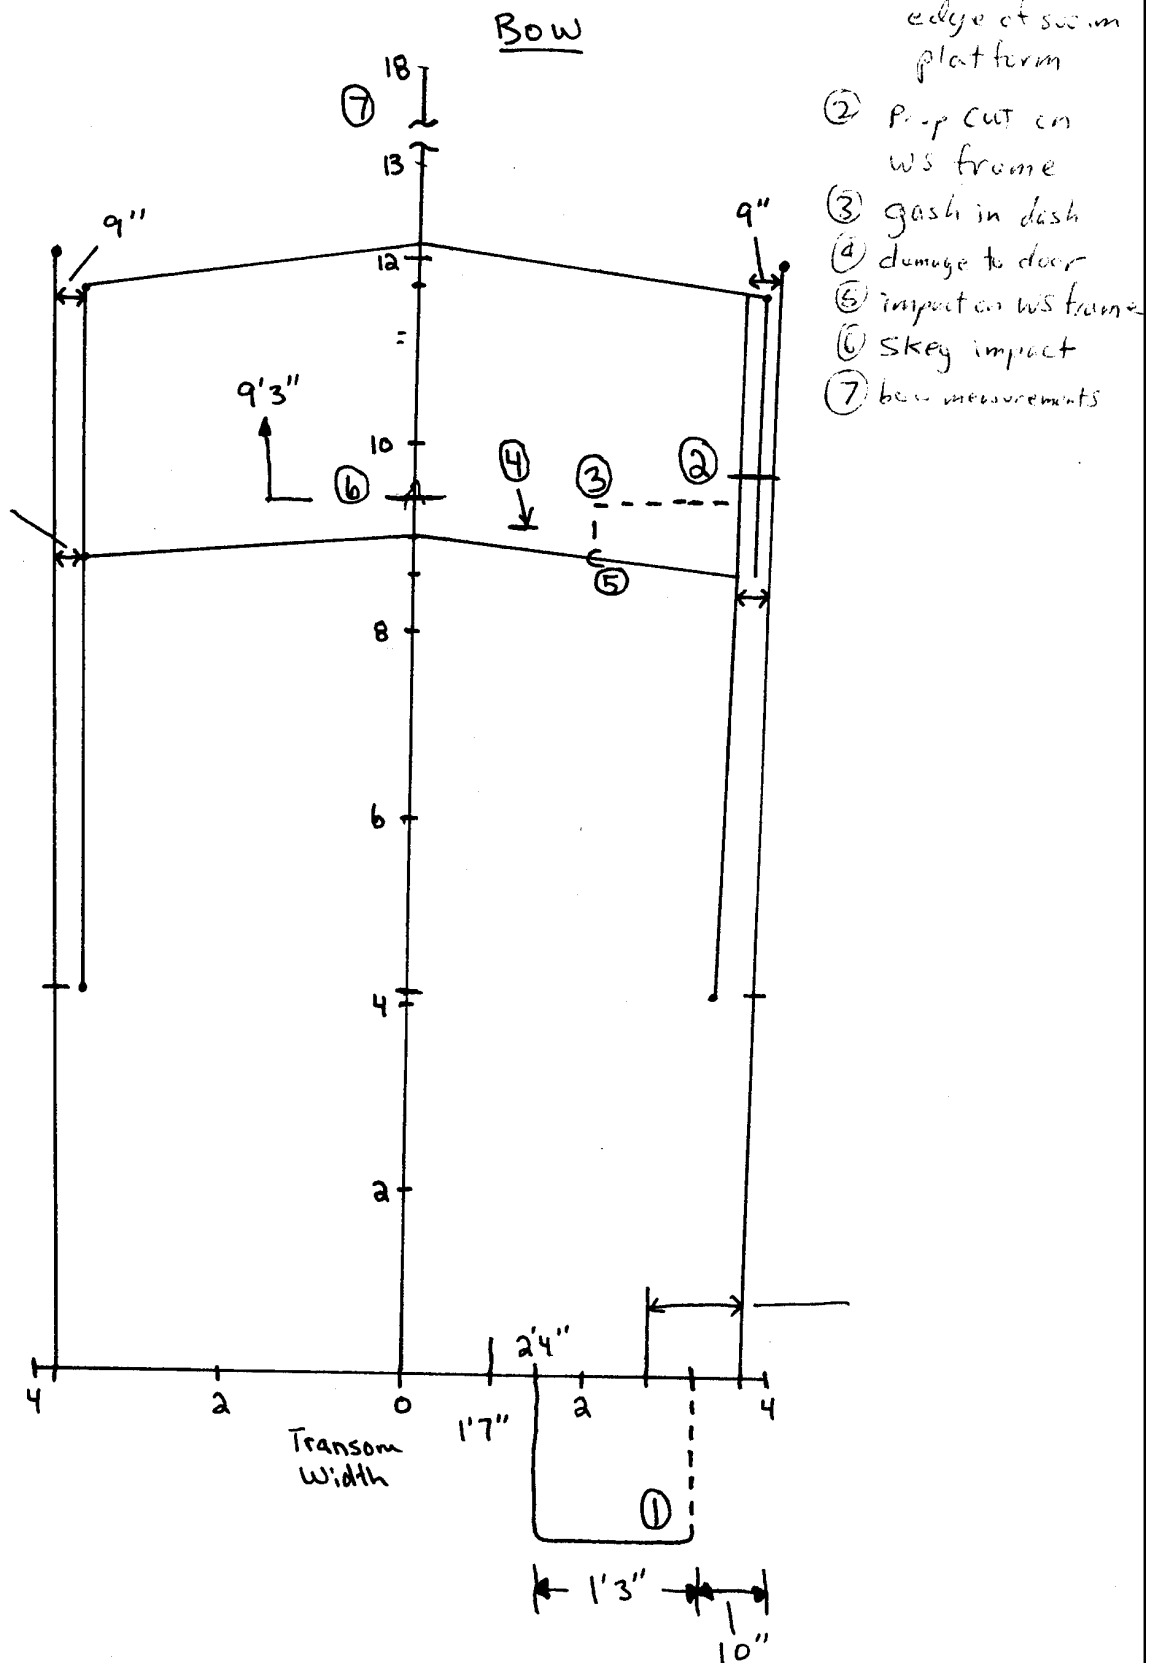
Figure 13-50

boat or the skeg. The windshield frame that ran along the side of the boat, parallel to the centerline, had a single cut in it, transverse to the centerline of the boat. Figures 13-50 and 13-51 are sketches of the damage done to the target boat.

An analysis was conducted to provide speed estimates based on the diagrams in Figure 13-50. The figure number, equation, and the results are presented in the summary that follows.

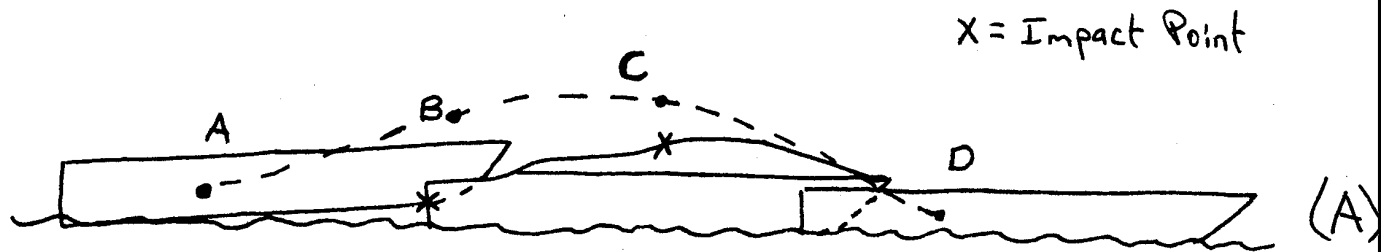
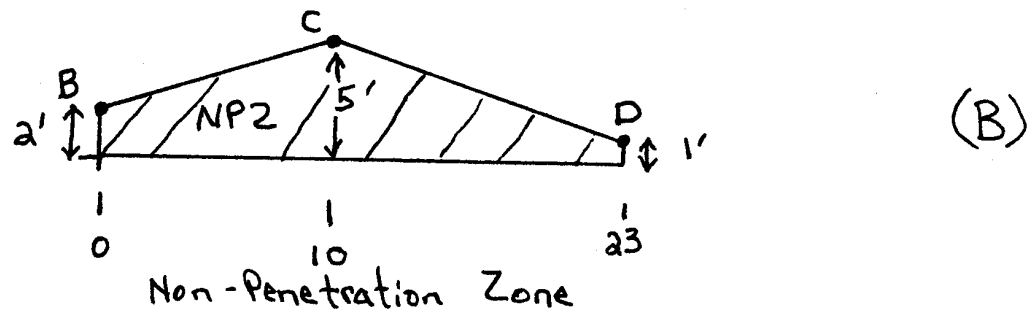
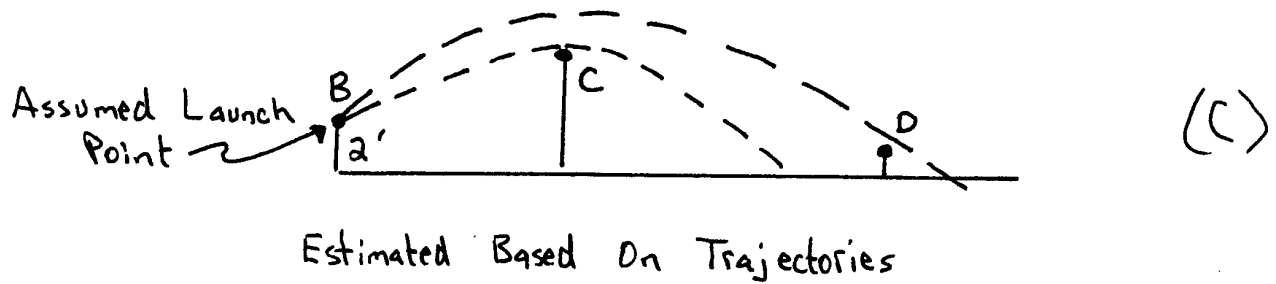
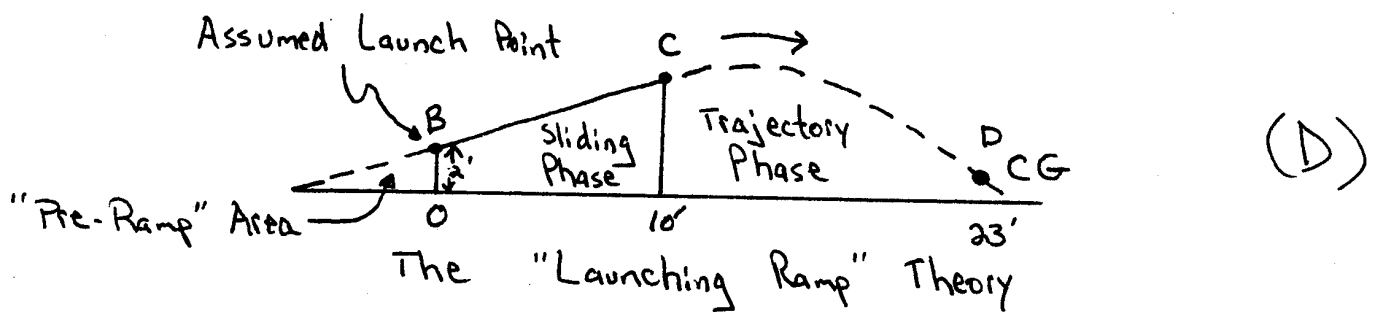
Figure 13-52

Both methods involve determining the area below which the CG could not have fallen during the collision. Figure 13-52a shows how this area was determined for accident number seven. We will refer to this area as the non-penetration zone (NPZ). Parts of the bullet boat will have clearly penetrated the NPZ, but not the CG. Figure 13-52b illustrates a possible NPZ for accident number seven. Obviously, the determination of this area is subjective and depends at least partly upon how much the target boat was depressed during the impact. Note that it is not necessary to know the vertical height of the CG within the bullet boat, since we are only interested in the change in the CG height and not the absolute height.

Method 2A: Now that we have established a NPZ, how do we analyze it? One method is to presume that the launch point of the CG is at or near the impact point, and assume that the rest of the motion can be analyzed as a trajectory motion problem. In certain accidents, this is clearly a reasonable approach when it is known that the bullet boat was essentially launched over the target boat. The appropriate trajectory formulas are selected based on the shape of the NPZ, and provide an estimate of the bullet boat's speed. Figure 13-52c illustrates this method.

The analysis is limited only to the sliding phase of the collision as labeled in Figure 13-52d. The derivation and background for this analysis can be found in Traffic Accident Reconstruction, Volume 2, Topic 862, Section 7. Consult the bibliography for complete information.

The above method needs additional refinement. The actual distance (d) to be used in these equations is open to discussion. This analysis did not consider what is labeled as the "pre-ramp area" in Figure 13-52d.

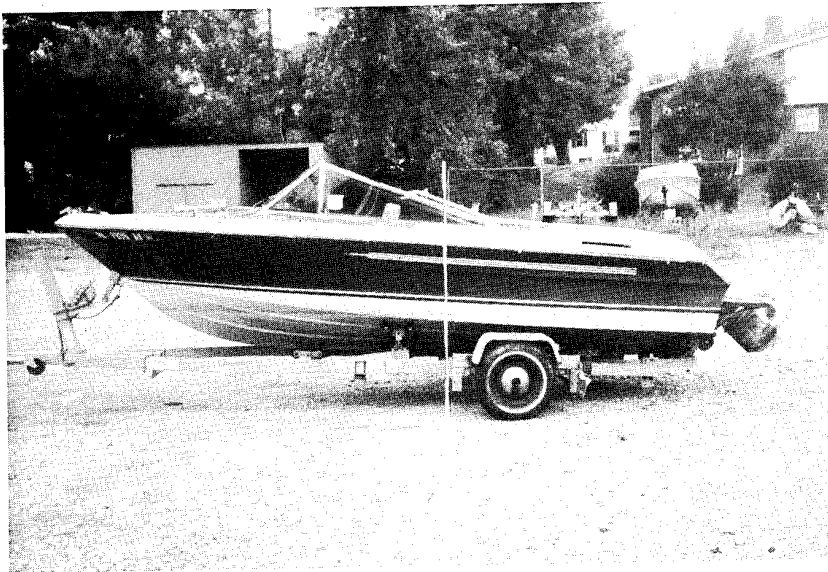
Figure 13-53

A 19 foot I/O traveling at idle speed was struck from the stern by a second vessel at night. The second vessel, in this case the bullet boat, struck the stern, and rode over a portion of the struck boat. The second vessel was released almost immediately after the accident; and therefore, was not available to us for analysis. An overall view of the target boat is shown in Figure 13-53. There were no fatalities in this accident.

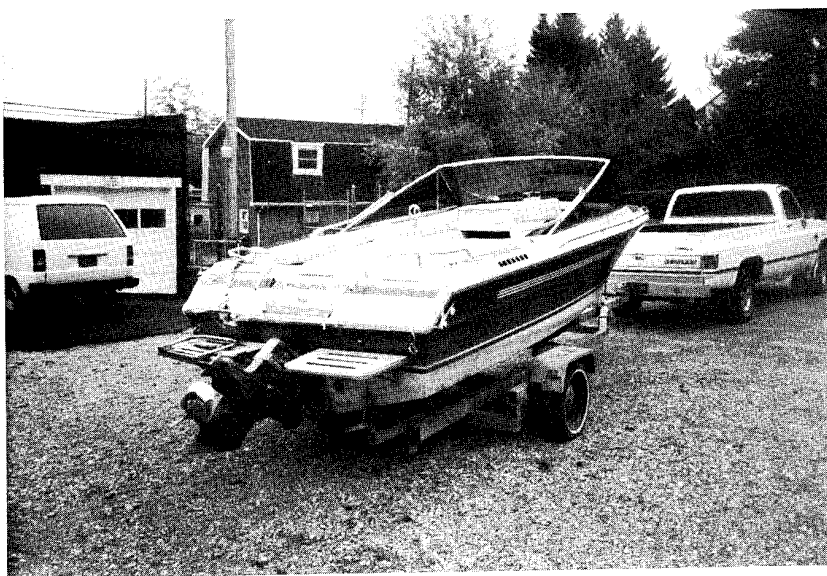
Figure 13-54

Damage to the rear of the boat is shown in Figure 13-54. The damage on the port side of the transom appears to be the point where the lower unit of the bullet boat passed through. If the target boat was traveling very slowly, then this would also be the area where the bow made initial contact. A handrail was crushed on the starboard side of the stern. The side windshield frame on the port side had been lightly struck, showing striations, and slight deformation outward.

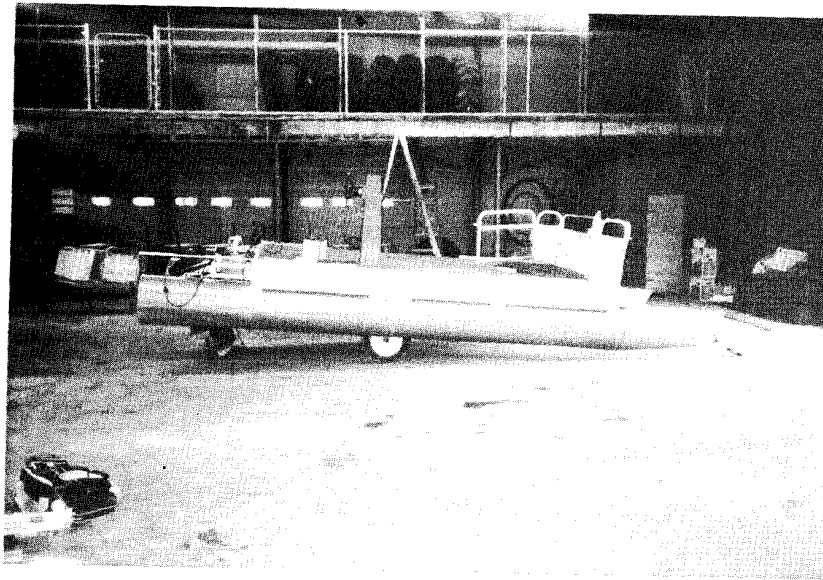
Figure 13-55

A 20 foot I/O open motorboat struck a 20 foot pontoon boat powered by a 40 HP outboard motor. The motorboat struck the pontoon boat on the port quarter and rode over the boat, exiting the starboard side near the stern. The pontoon boat carried nine passengers. Two were killed, and three were injured. Three occupants were on board the motorboat, one of which suffered minor injuries. The occupants on board the motorboat said that the jolt was fairly minor, as if they had run over a log. The port pontoon was punctured by the motorboat, and quickly filled with water. The pontoon boat then quickly capsized. An overall view of the pontoon boat and the motorboat are shown in Figures 13-55 and 13-56 respectively. The primary questions in this accident were as follows:

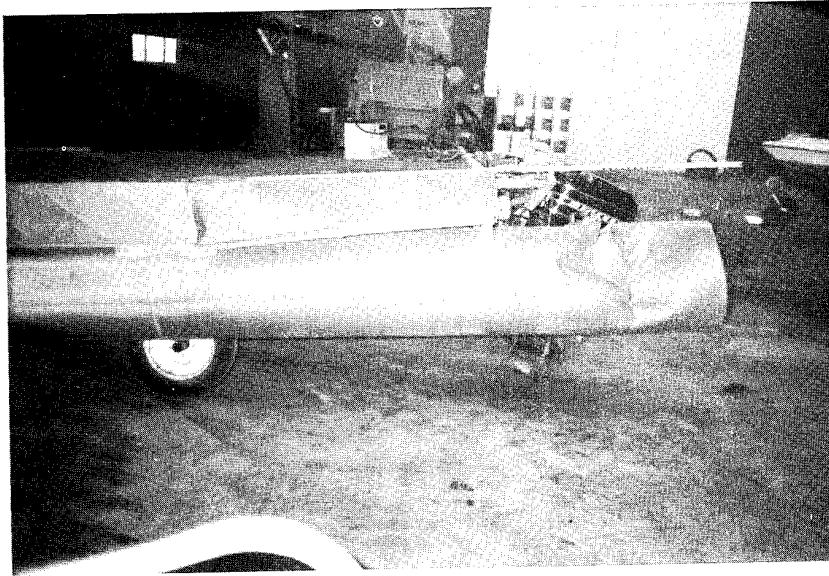
Figure 13-57 and 13-58 show the damage to the port quarter of the pontoon boat. Damage to the pontoon caused by the outdrive and propeller is clearly visible on the port pontoon. This is probably the most obvious example of damage matching. The propeller of the boat clearly caused this damage.

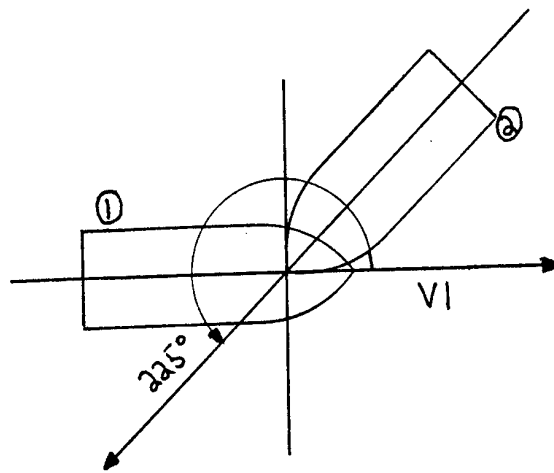
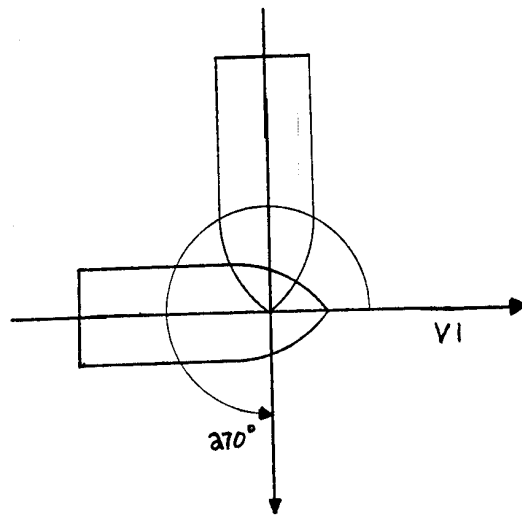
Figure 13-72

Accident No. 10

Possible Impact Angle for Accident No. 10. The Vector Impact Angles Range From Approximately 225° to 270° .

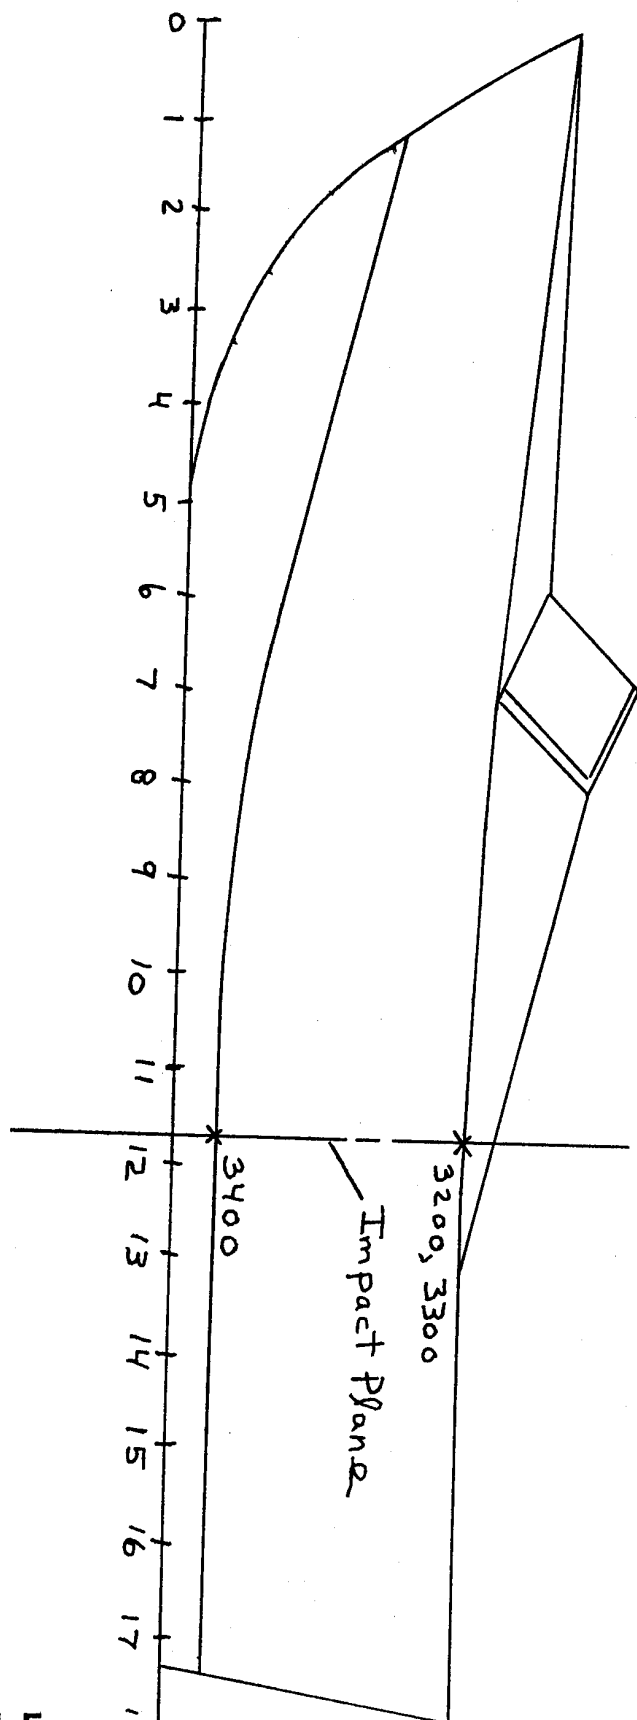
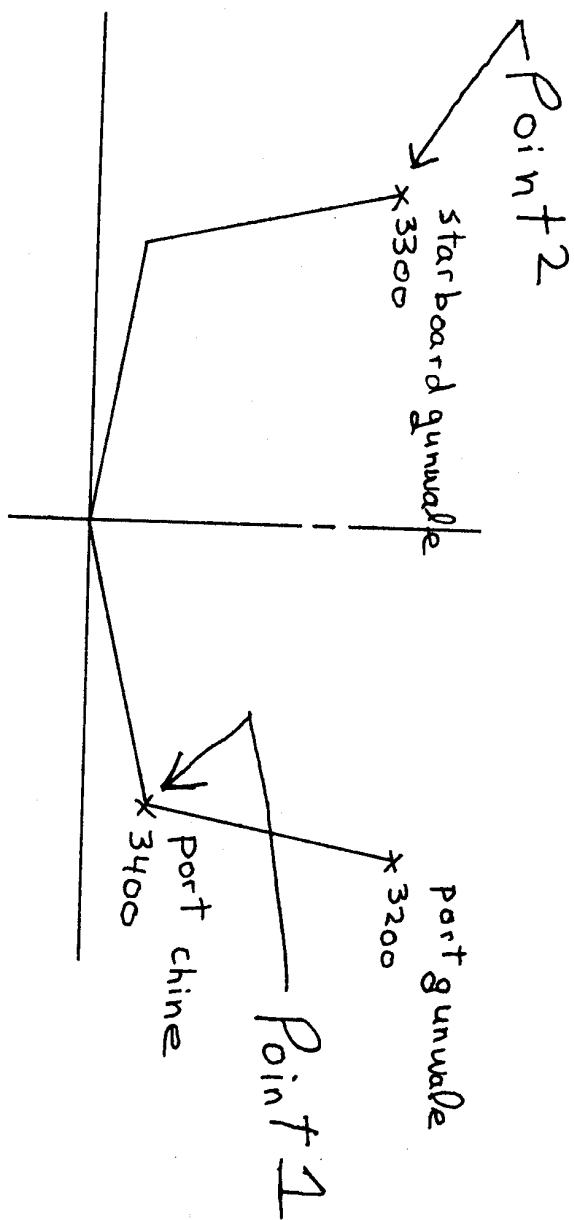
Even though much of the hull material on the struck side is damaged or swept away, the dynamics of the collision are largely determined by two hard points on the vessel. Choosing the proper location of these hard points was critical to the success of the collision. The diagram in Figure 14-5 illustrates this point. Points 1 and 2 represent the locations chosen for these hardpoints.

Target Boat Geometry for
the Collision Analysis.

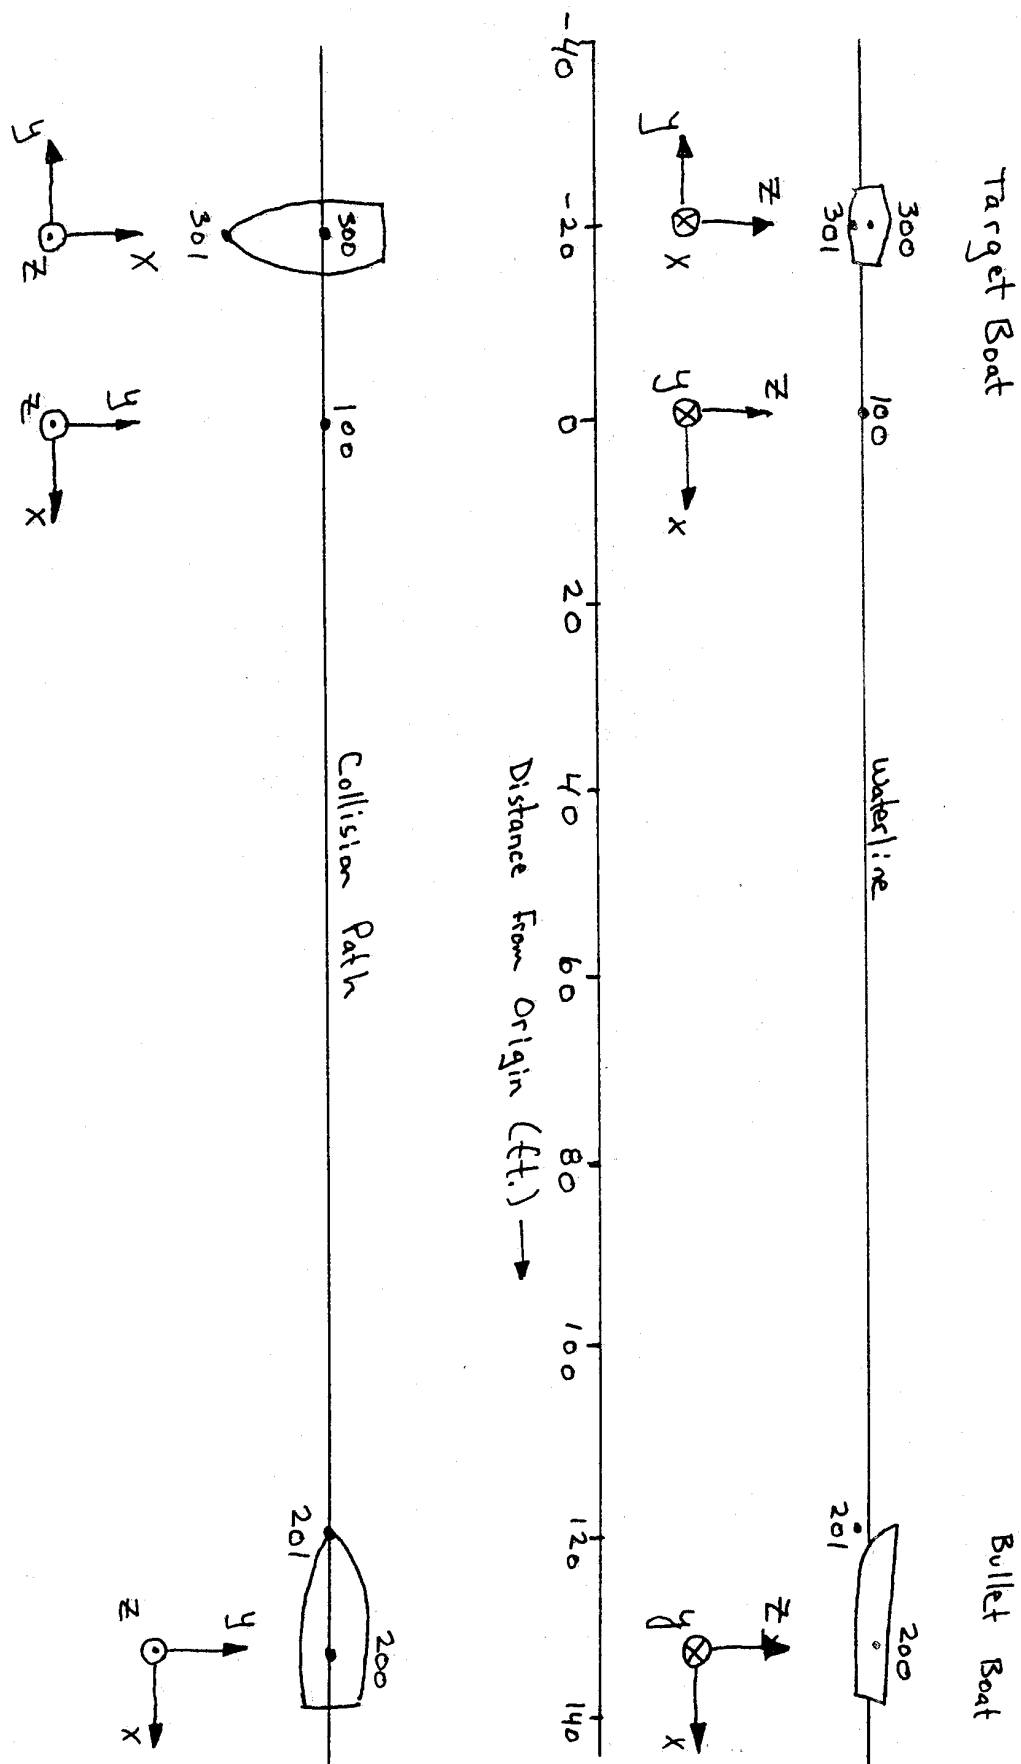
Figure 14-6 shows the overall geometry of the collision scene at the beginning of the simulation run. Five important markers are included in this figure. Marker number 100 is a fixed reference point, located on the surface of the water in line with the path of the bullet boat. This point serves as the global origin for the simulation. Markers 200 and 201 are fixed relative to part number 2 (the bullet boat). Markers 300 and 301 are fixed relative to part number 3 (the target boat). Markers 200 and 300 are identified in the respective part 2 and part 3 statements as center of mass markers. Markers 201 and 301 are positioned directly under the bow points of the boats, on the extension of the keel lines, as shown in Figure 14-5.

Basic Geometry of the 30 mph Collision.

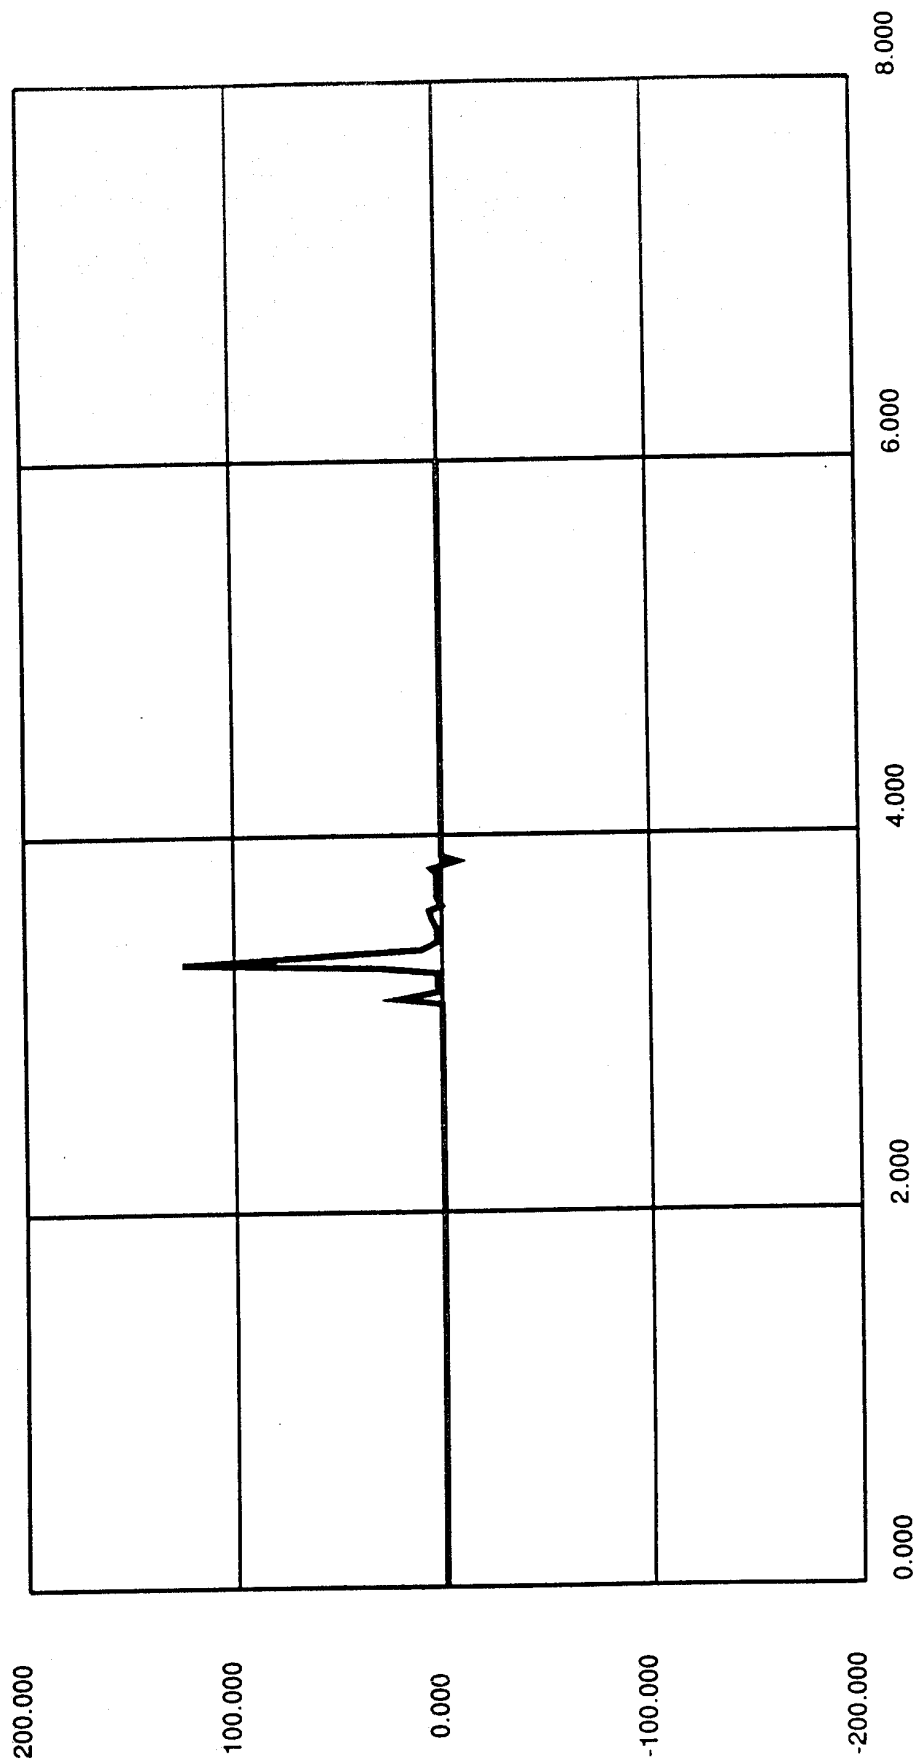
Figure 14-12 and 14-13 show the accelerations for the bullet boat in the x and z axis respectively. The units are given in ft/sec². Note that the plot for the z axis shows the pre-impact accelerations at approximately zero. Thus the values obtained from the graph for the z axis must have the component of acceleration due to gravity added for our analysis. This must be done since we are really interested in the forces on the occupants, as calculated from $F = ma$. Thus, components of acceleration for the z axis expressed in feet/per second² will have the value of 32.2 added to them. When acceleration is expressed in g's, the force on an object can be calculated by multiplying this number times the weight of the object. If this sounds confusing, think of the force between the person and the boat if the boat were suddenly allowed to accelerate downward at 32.2 ft/sec/sec. The contact force would be zero! However, if the same boat were suddenly accelerated upward at 32.2 ft/sec/sec, the contact force between the occupant the boat would be two times the occupant weight. Thus, a person weighing 150 lbs would exert a force of 300 lbs on the boat.

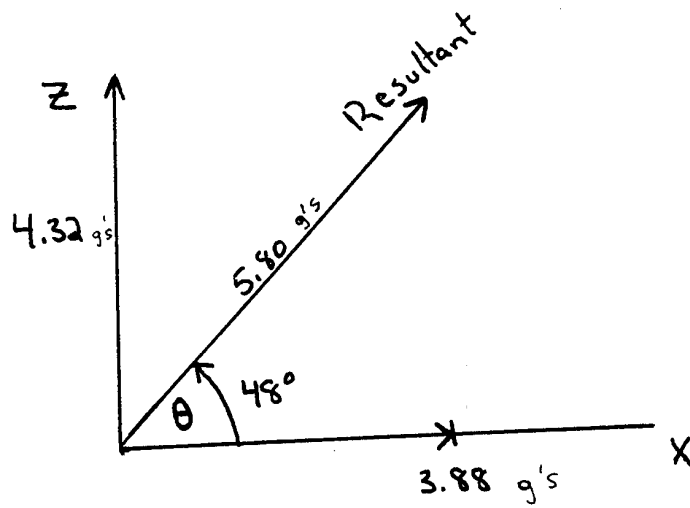
What affect does this have on the occupants? The occupants will experience a force that acts on them opposite to the direction of the acceleration vector and equal in magnitude to their mass times their weight ($F = ma$). Figure 14-16 shows the direction relative to a fixed axis of the maximum experienced acceleration at the CG of the target boat.

Resultant Acceleration Vector of the
Bullet Boat CG During Impact.
